## Lessons Learned Applying Multiple Remediation Technologies at Air Force Plant 4

**Bruce Alleman, Oneida Total Integrated Enterprises (OTIE)**  
**Kent Glover, Air Force Civil Engineer Center, Environmental Management Directorate, Technical Division (CZTE)**  
**John Wolfe, Air Force Civil Engineer Center, Environmental Management Directorate, Operations Division (CZOM)**  
**9 May 2018**

Presented at the FRTR Annual Meeting, Reston VA

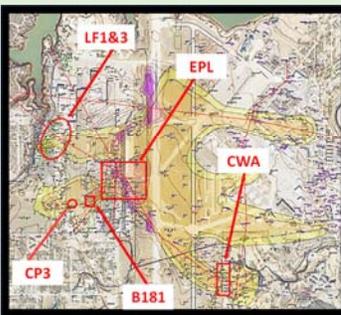
## TCE Plume Areas of Concern

- Building 181 (B181)
  - Source of eastern plume
- East Parking Lot (EPL)
  - Dissolved-phase plume
- Carswell Area (CWA)
  - Southern Lobe of the EPL Plume
- Landfill 1 and Landfill 3 (LF1&3)
  - DNAPL source and dissolved-phase plume
- Chrome Pit 3 (CP3)
  - Chrome waste disposal pit
- Separate TCE source from B181

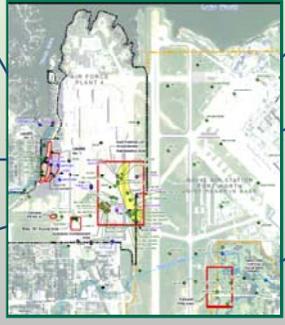
## AFP4 Remedial Technologies

Technology assessments **bolded and underlined**

- LF1**
  - Excavation (1983)
  - P&T/French Drains (FDs) (1983-2014)
  - EISB FDs (2013-2014)
  - DNAPL Recovery** (2013 to Present)
- LF3**
  - VEP (1994-2001)
  - Phyto (1998)
  - Biowall (2004)
  - GCW** (2008-2012)
  - EISB (2008-2015)
- CP3**
  - Excavation (1983/1984)
  - ISCO (2008)
  - EISB (2010)
- EPL**
  - P&T** (1993-2015)
  - EISB (2013-2018)
- B181**
  - SVE** (1993-2002)
  - ERH** (2002-2004)
  - EISB (2008-2011)
  - ISCO (2013)
- CWA**
  - P&T (1994-2002)
  - Phyto (1996-2005)
  - ZVI PRB** (2002)
  - Off-base ICs (2007)
  - PRB extension & conversion to EISB (2013-2015)

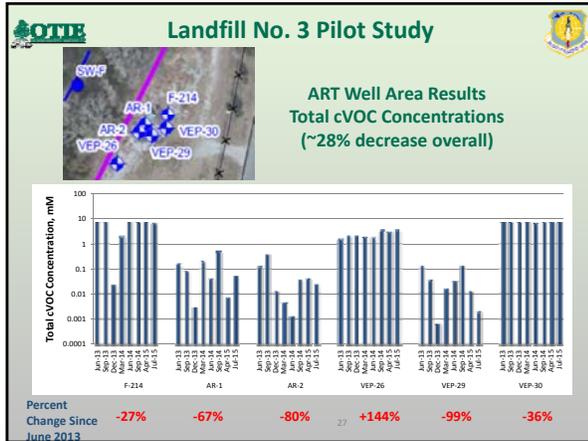
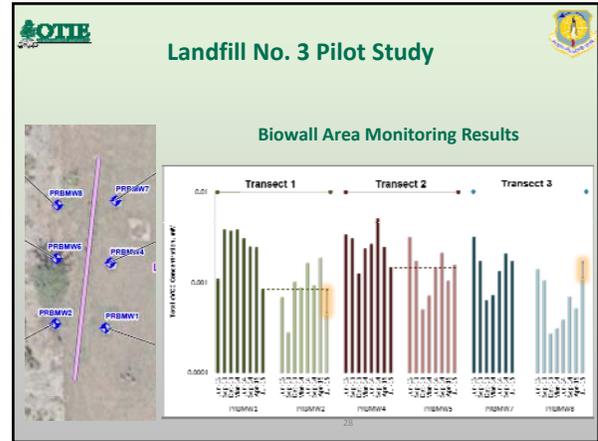
### LF3 EISB Pilot Study

- Objective
  - Inject biostimulants into the biowall and ART well area to reduce LF3 groundwater cVOC concentrations
- Implementation Overview
  - First injections performed May - October 2013
    - EHC-L (*food*)
    - KB-1 (*bacteria*)
  - Second injections performed March - September 2015
    - EHC-L (*food*)
    - EHC (*food + ZVI*)
